# QUESTIONS ON THE WTC INVESTIGATION

JAMES G. QUINTIERE\*

Abstract - A critique of the World Trade Center investigation with respect to the cause of the collapse of towers 1 and 2 is presented. The official investigation conducted by the National Institute of Standards and Technology (NIST) concluded that the collapse was due to the fires heating the core columns that were stripped of insulation by the aircraft impacts. An alternative cause is considered that puts the cause on insufficient insulation of the steel truss floor members. Evidence for the latter is supported by NIST analysis of a truss member, Underwriter Laboratory furnace tests of the floor assembly, and engineering calculations and scale model tests conducted at the University of Maryland. The presentation is couched in terms of 10 questions for NIST.

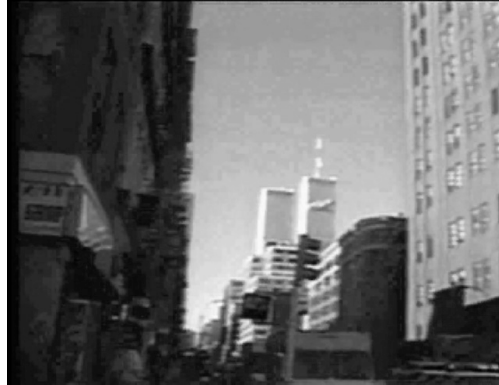
Figure1. Impact of WTC 1, North tower

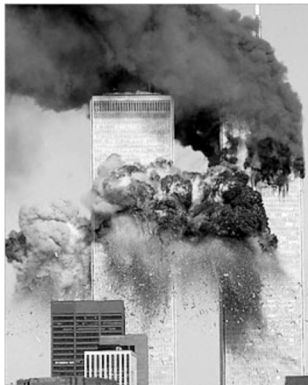
Figure 2. Impact of WTC 2

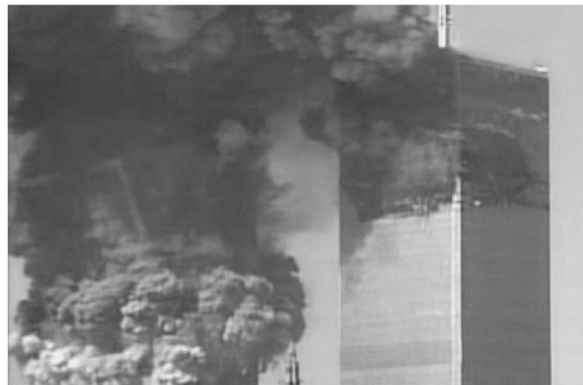
Figure 3. Collapse of the South tower

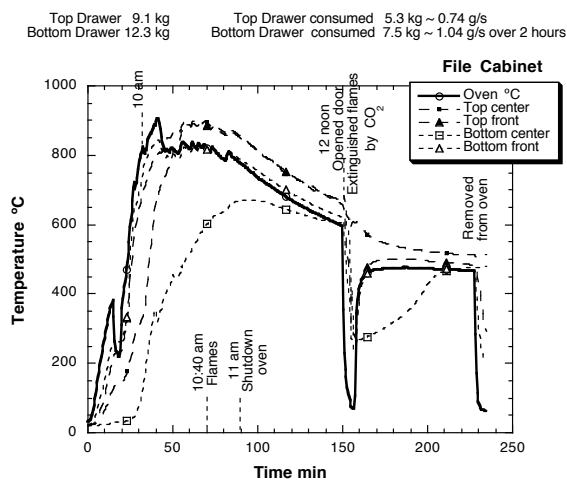
Figure 7. Burning of paper in file drawers of a metal cabinet

After communicating our results to NIST, some scientists from NIST remarked to me that paper in file cabinets does not fully burn. Not finding any information on this subject in the literature, I conducted my own experiments. Two file drawers in a cabinet loaded at 50 % and to full capacity were subjected to furnace conditions of 600 to 800 °C for 2 hours. Figure 7 shows the results of the tests. Approximately 60 % of the paper was vaporized with the remainder consisting of char and ash. This is not an

uncommon distribution for cellulosic material in a fire. Hence, the file paper would follow the behavior of wood in a fire.

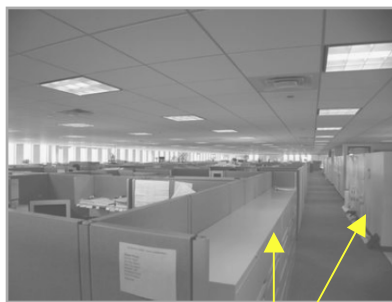
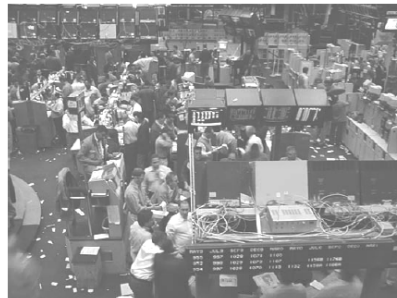
Office floor  
note: files  
storage

Trader floor

Figure 8. Actual WTC occupancies according to NIST

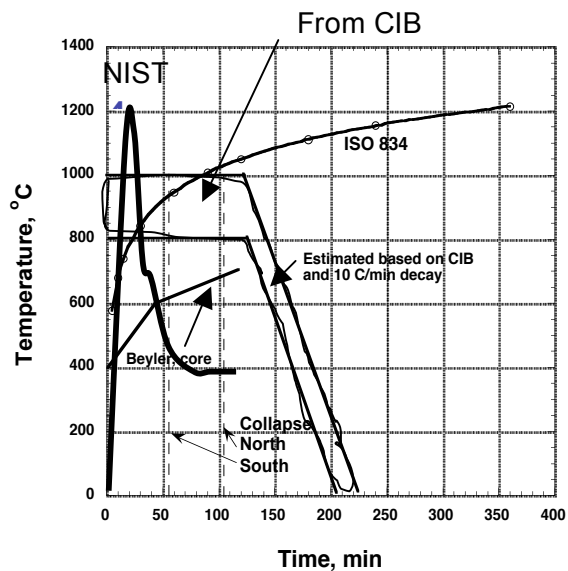
Figure 10. Estimates of the fire temperature

the basis for design estimates. Recently the SFPE has produced a guide on such formulas. Figure 10 shows results for temperature and its duration based a formula established by the extensive CIB data base.<sup>2</sup> Here is an example of applying the CIB correlations to the WTC fires with a fuel loading of 7.5 psf (34 kg/m<sup>2</sup>). It is compared to NIST temperature for 4 psf loading at a given floor location. The results also show the standard fire temperature furnace curve and the temperature suggested by Beyler et al.<sup>11</sup> The CIB fire is longer than the NIST local fire prediction, and indicates fire heating beyond the collapse times of each building. These CIB-estimated results will be used later to compute the steel temperature in the trusses.

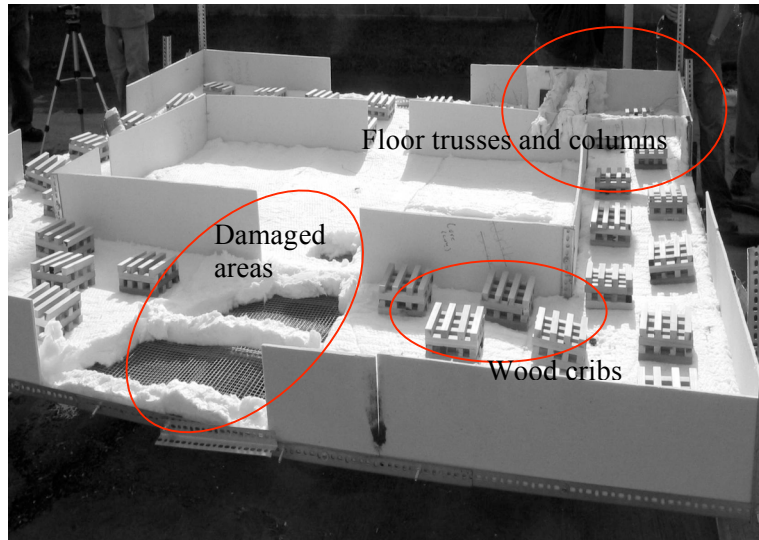
Figure 12. Scale model floor with no ceiling

Students considered the office fuel load and the aircraft fuel. Wood cribs simulated a 10-psf (45 kg/m<sup>3</sup>) office fuel load. The construction of the structure was based on the heat transfer scaling and required relatively low density material. Measurements included temperature, heat flux, fuel mass loss, and smoke obscuration. Several external columns and insulated trusses (unloaded) were included according to the scaling laws. The insulation on the scale model is based on heat transfer consideration, and is not based on geometric scale. Consequently, the insulation thickness was applied to the complete truss, not the individual components. Photographs of the assembly and fire are shown in Figures 12 and 13. Figure 14 shows the results of the scale model in terms of the temperatures. In comparison to the NIST computations for comparable temperatures on the 97<sup>th</sup> floor, the NIST upper layer temperatures are only about 800 °C for about 20 minutes, while the model results show a given region is in excess of 800 °C for about 45 minutes. This is a more severe fire condition. Moreover, the scale model is likely to give lower flame temperatures due to the scale effect on radiation. Thus, the scale model shows a similar movement of the fire about the floor as the NIST computations, but more significantly shows a

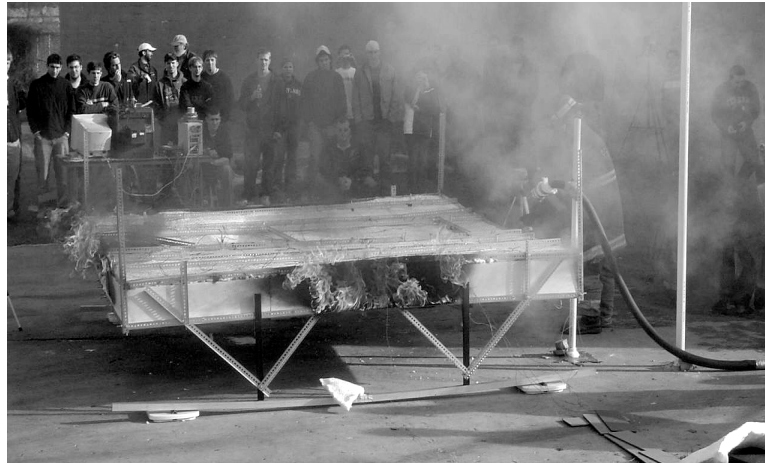
Figure 13. Scale model test in progress

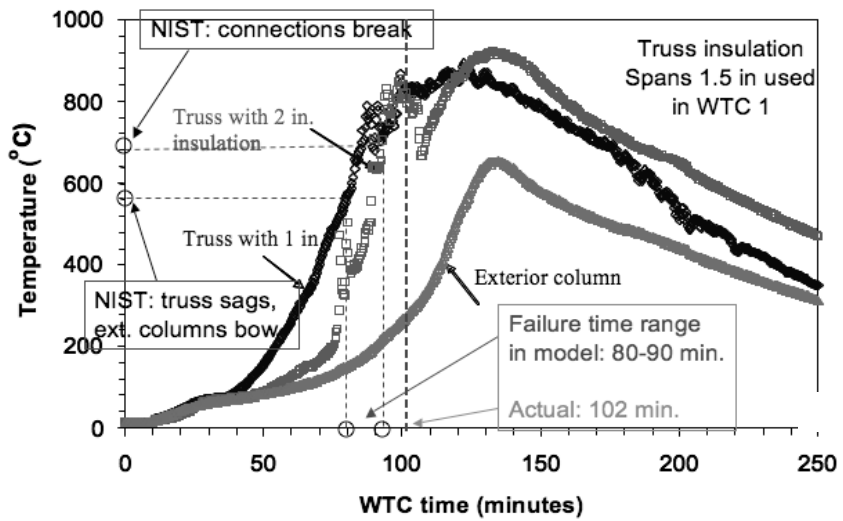
Figure 15. Scale model truss temperatures

longer duration of the flames. Indeed, the scale model shows in Figure 16 that the steel trusses in the model, with scaled insulation thicknesses of 1 and 2 inches, respectively, indicate failure in 80 to 90 minutes compared to an actual failure in WTC 1 of 102 minutes. We feel this gives some credibility of the scale model result, and supports the hypothesis that the trusses are at the root cause.
